PROJECT PROFILE

Toyota Headquarters – Plano, Texas

Toyota Headquarters Proves Excavation is Final Authority for Waterproofing Solutions

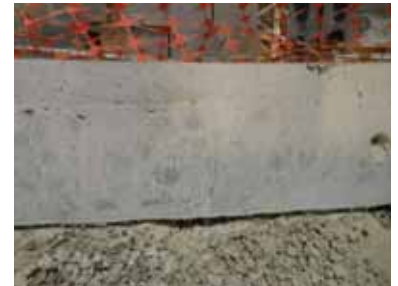
“Our guys thought adhesion was greatly enhanced and the membrane went down much faster,” Jahant said. “It definitely has an aggressive bond at the laps. There was an area where the concrete workers had a problem with the pour and had to remove a section of the floor slab. Typically you don’t see under the slab

once it’s installed. But we had to cut out an area to fix it. We could see the product was well-bonded to underside of the slab. That was impressive.” (See top right photo)
