# **Stucco Repair and Maintenance**

## **Stucco Repair and Maintenance**

#### **Condition: Cracking**

#### **Condition: Water Intrusion**

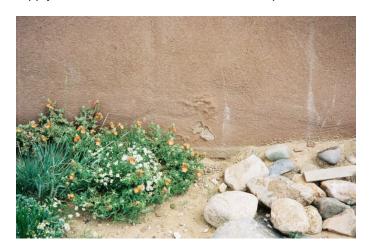
Photo 1: The blistered area at the base of this wall can be removed with a hand tool, and new color/texture matched finish applied to repair it. The likely root cause of this blister is ground water that seeps into the stem wall below and wicks up into the stucco. A canale (scupper) from the roof above drains water directly into the ground and not away from the wall. A diverter that directs water away from the wall would prevent recurrence.

- 1. Remove the blistered stucco finish with a scraper or other hand tool to adjacent well adhered finish.
- 2. If the stucco surface is chalky, clean and apply primer or surface conditioner (831 Sto Plex W) to restore the integrity of the surface.
- 3. If the stucco is weak, loose, or scaling, remove the weak material with a scraper or wire brush to a uniform depth and to where it is firm. Dampen the prepared surface and apply stucco base coat so it is even with the adjacent stucco. Moist cure. Proprietary stucco patch materials are also available from Sto such as 244 Sto Leveler. Follow the manufacturer's instructions for these materials.
- 4. Apply color/texture matched finish to the repaired stucco surface.

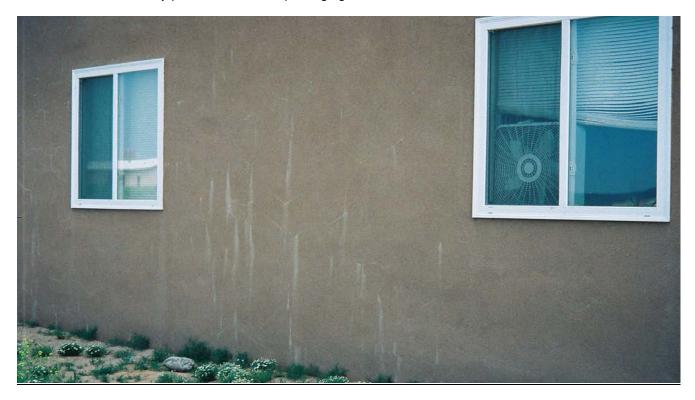
Photo 1: Efflorescence can be cleaned with a mild acid solution to remove unsightly stains on the exterior surface of the stucco.

Efflorescence can generally be removed by light washing with a cleaning agent. A common household solution is vinegar and warm water. Proprietary cleansers<sup>1</sup> are also available from a number of different sources (see notes below). Care should be taken to avoid heavy abrasion of the surface which could damage the integrity of the textured material. A soft bristle scrub brush should be used to scrub the affected area with the cleaning solution. Always try a small inconspicuous area first to be sure of desired results. When using proprietary cleansers follow the instructions and safety precautions on the packaging.
